THE  
RECONSTRUCTION  
OF THE  
Q'ESHWACHAKA

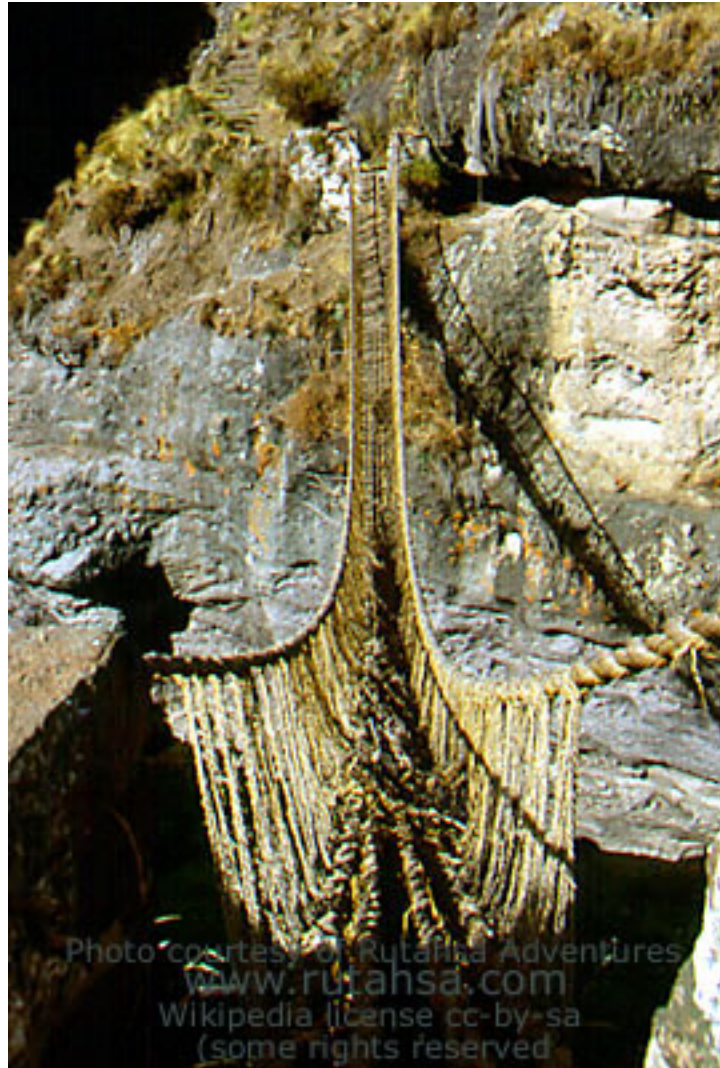
**The old bridge is sagging badly.**

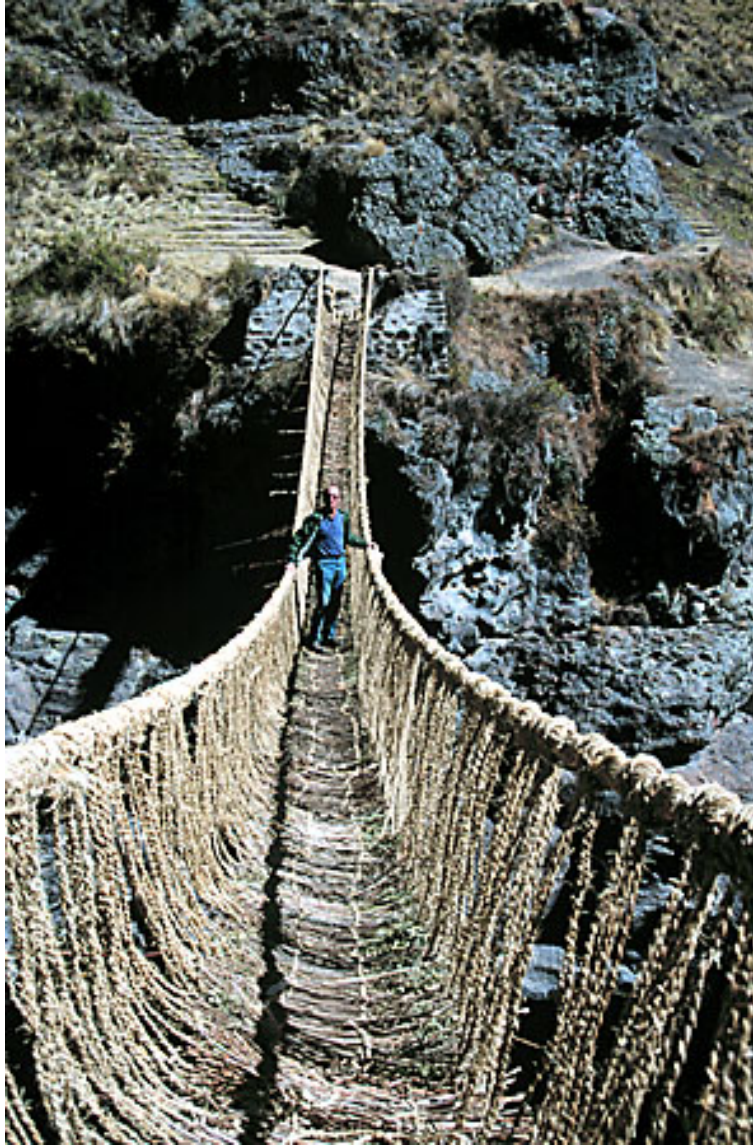
**The new bridge is complete  
and sags much less.**

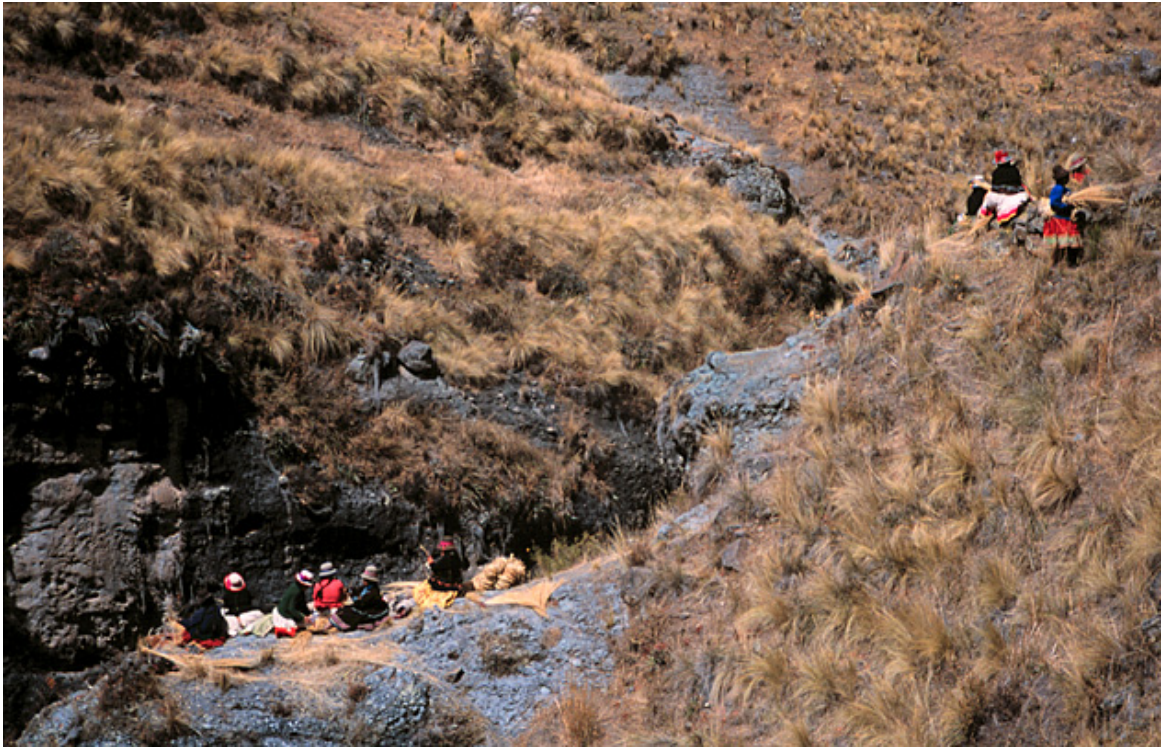
**Workers gather ichu grass in the hills and make the lashings.**

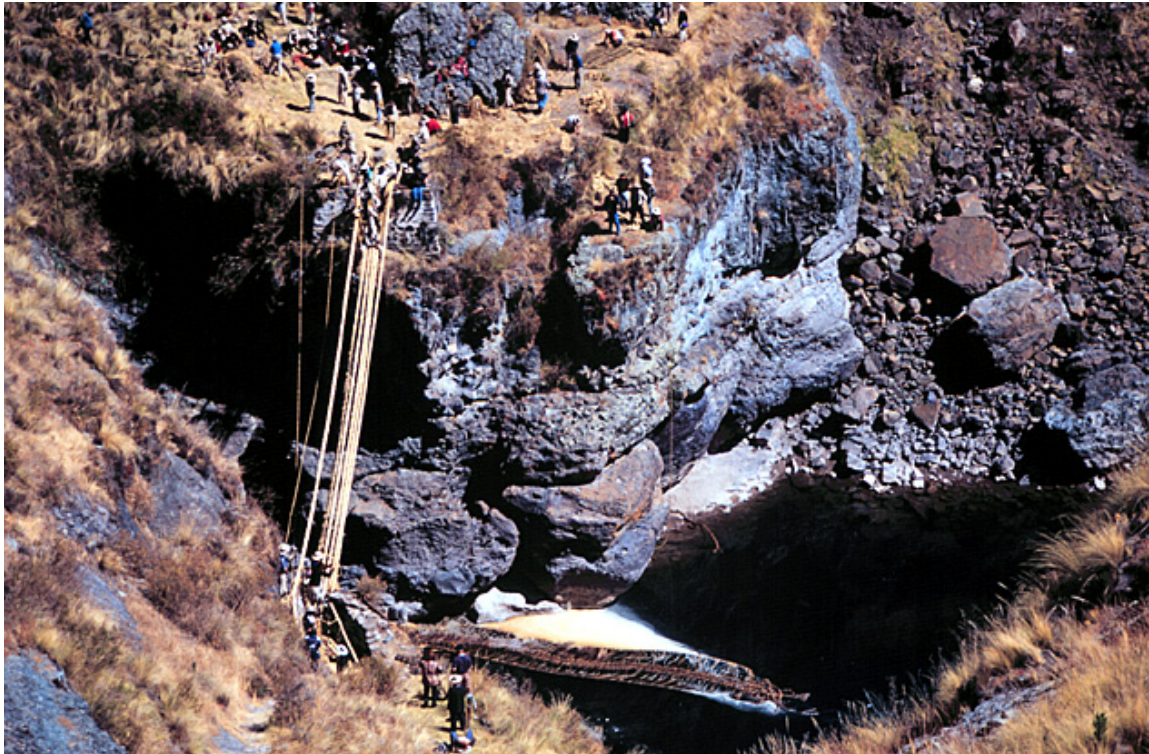
**The main cables and ropes are put in place across the gorge.**

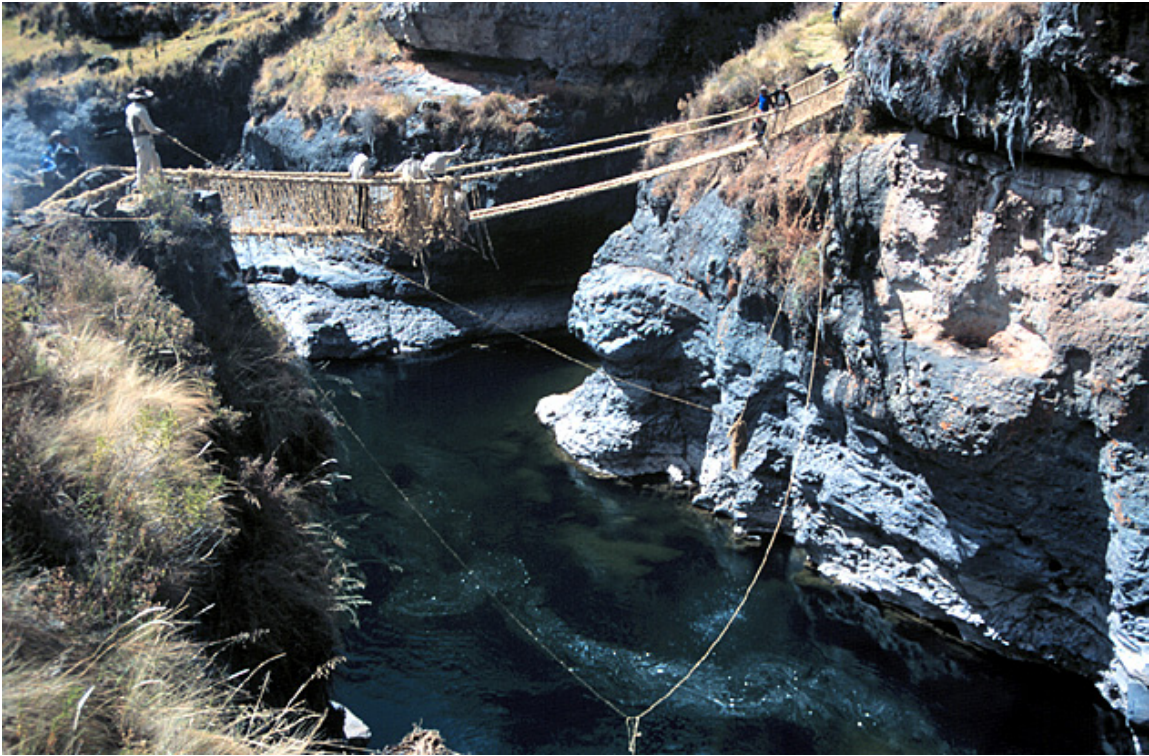
**The hand ropes are lashed to the main side cables.**

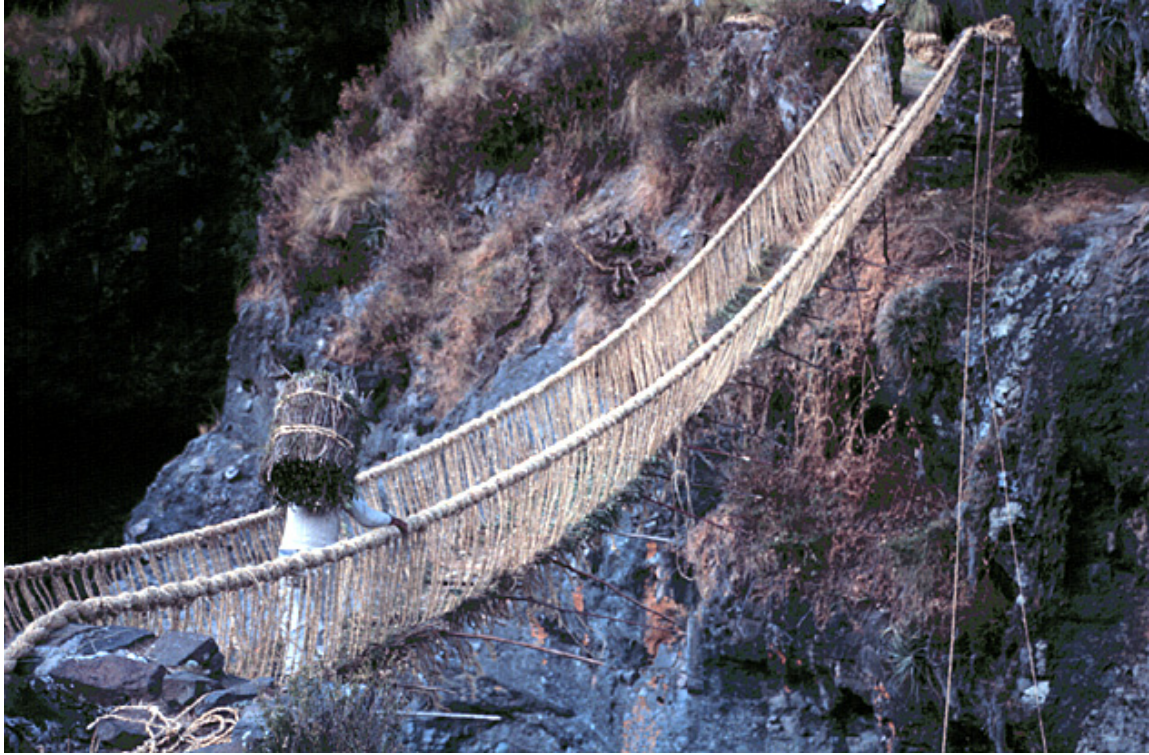
**The trimmed mat rolls  
form the bridge deck.**
